# A Thermography Success Story

## A Success Story

West Bend Insurance Company  
March 19, 2024

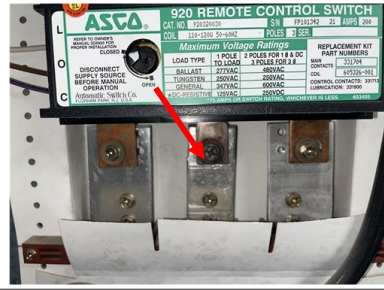
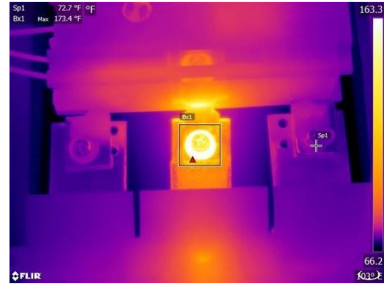
Rec. No.:	Initial/Follow-up:	Recommendation Status:	
2024-03-001	Initial	Open

Below is the image that captured the main disconnect switch problem.

Location Area:	Main Electrical Mezzanine
		Equipment Location:	Breaker Panel- A
		Equipment ID:	B Phase (Middle) Remote Switch Bus
		Est. Repair Cost Before Failure:	\$1,000.00
		Est. Repair Cost After Failure:	\$1,000.00
		Estimated % of Production:	10%
		Estimated Down Time:	4 Hours

Box 1 Max Temp	173.4°F		
Box 1 Temp Rise	100.7°F

**Elevated Temperature**  
The B phase (middle) bus connection on the load side of the remote switch is showing an elevated temperature and damage to the bus. Due to the excessive temperatures and damage, it is recommended that the remote switch be replaced, and the bus repaired or replaced as needed. ELEVATED to **SEVERE** due to the possible downtime in the event of failure and the annealing of the bus. NOTE- The electrical contractor was ordering the new switch prior to departing the location.
