A Thermography Success Story

A Success Story

Finding No.	IR-20-07-10-01	CATEGORY	CRITICAL
--------------------	----------------	-----------------	-----------------

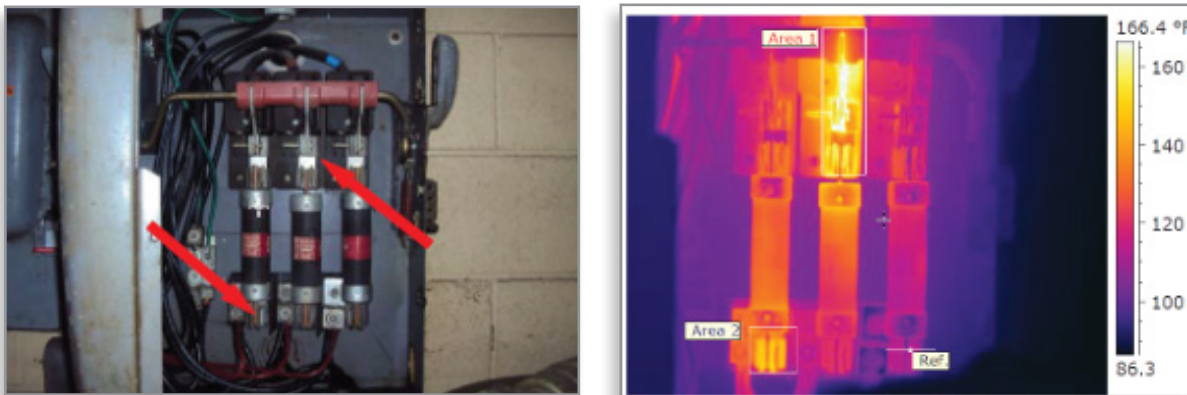
These photos illustrate how an infrared thermographic image will look.
